TSB No.	KCE10-71-V030-ED	TSB Type	Customer Satisfaction (Complaint Base)	Language	English
Distributor	C41VD(LOCAL)	Published	7/15/2010	Modified	
Model		Cee'd [ED]-(2008MY)		Issue No.	100S08
Area & Distributor	East Europe & Falcon Auto				
Gr./Sys./Comp	Обогреватель, Вентиляция, Кондиционер / Общие сведения /				
Symptom	EL7000 - instrument malfunction				
Subject	FRONT END MODULE WIRING INSPECTION AND REPAIR (AMBIENT SENSOR #1, #2)

This bulletin provides the repairing procedure for the front end module wiring (ambient sensors #1, #2 line)

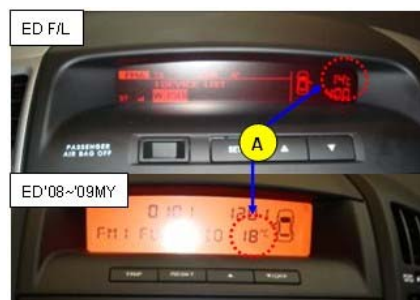
- 1) Verify that the vehicle is affected one by identifying the VIN from the VIN range.
- 2) Inspect temperature value on the multifunction display (A) is showing correct value.

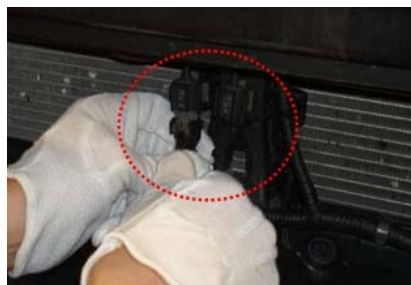
5) Disconnect the ambient sensors #1 (connector E84-1), ambient sensor #2 (connector E84-2) and measure the sensor resistance between the terminals according to the table below to eliminate the sensors malfunction.

Ambient Temperature [°C (°F)]	Resistance between terminals 1 and 2 (kΩ)
-10	158.2 ± 3%
0(32)	95.1 ± 3%
10(50)	58.8 ± 3%
20(68)	37.3 ± 3%

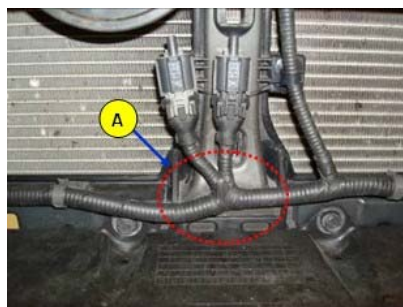
- Symptom/Condition
Some cee'd (ED) vehicles might experience the ambient temperature or in car temperature (on multifunction display) malfunction.
- Cause
Front end module wiring internal interference
- Countermeasure
Inspect Ambient sensor #1 (Auto Air-conditioning system only*), Ambient sensor #2 (Multifunction display) and the front end wiring according to the service procedure bellow.
*If equipped

6) Locate the front end module wiring joint (A) from ambient sensors #1, #2 into the main line
